# Benex Case Study

Dr. Dean Licenblat

Director Sydney Dental Aesthetics & Implants

**Cracked Root & Failed RCT**

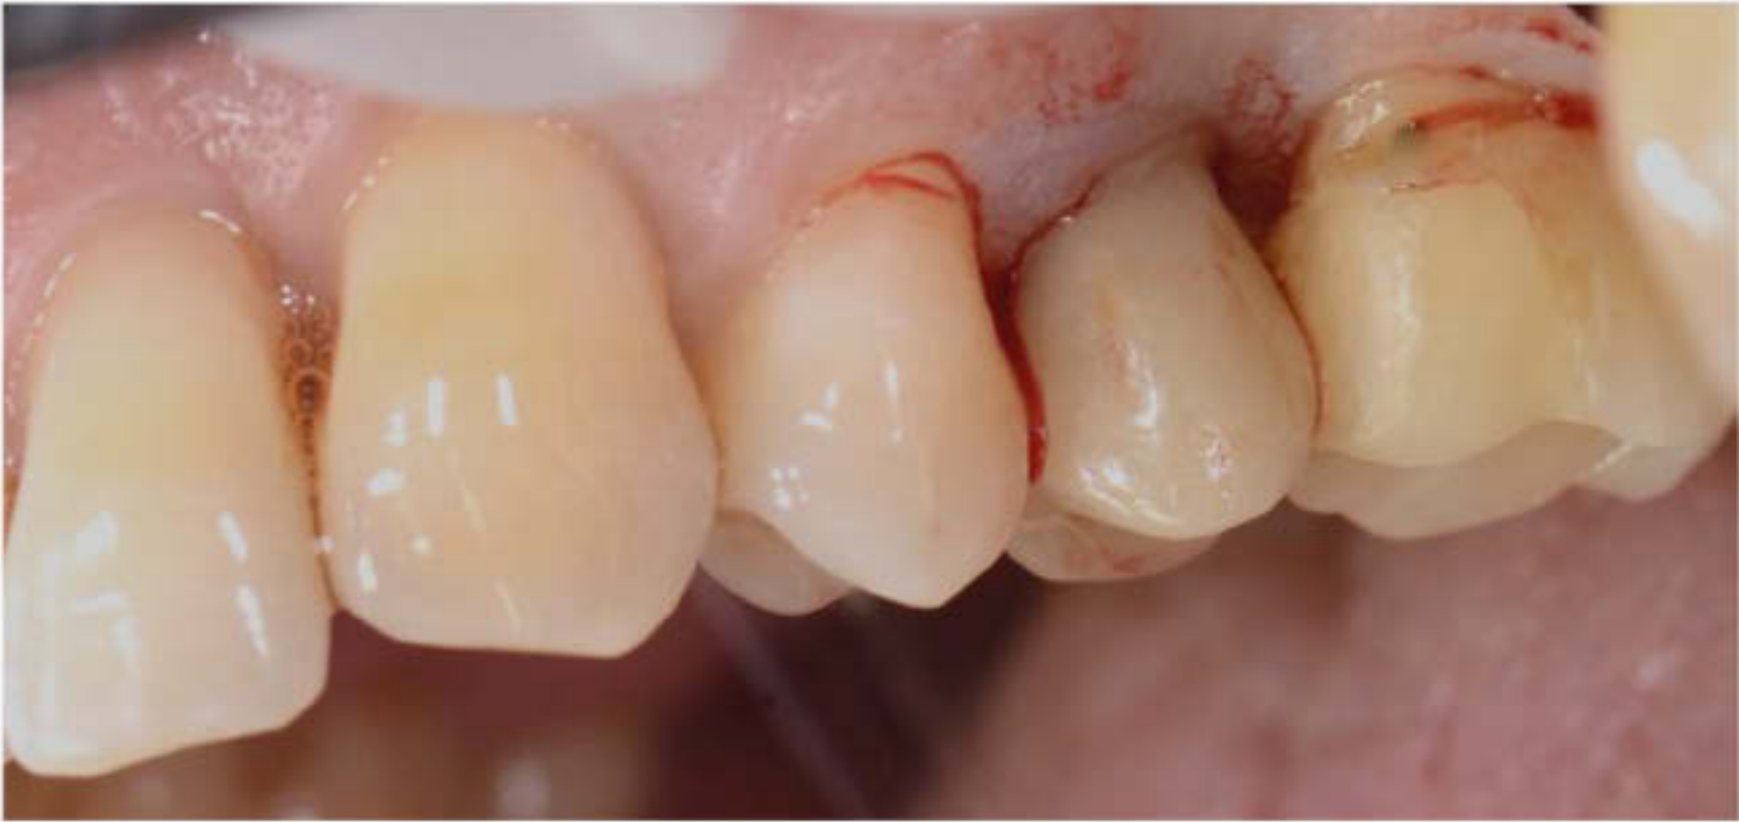
**Pre-Op**

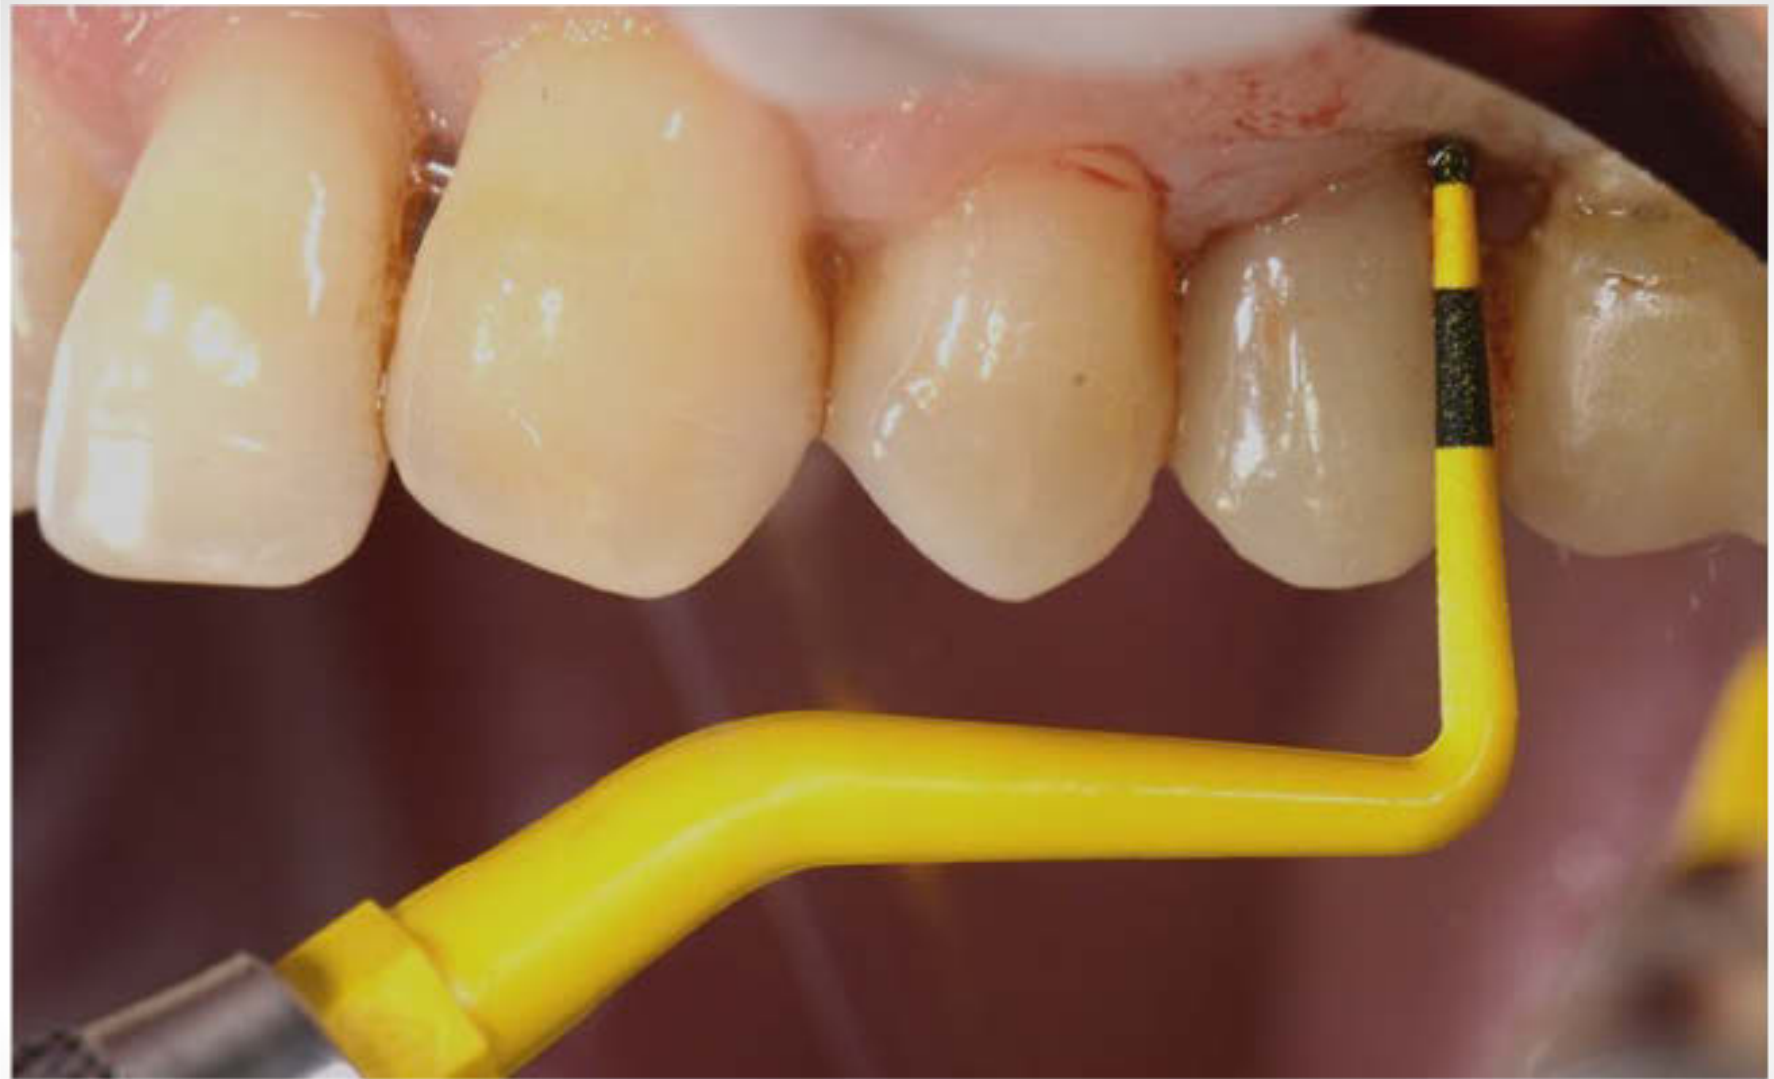
**5mm probing depth at crack site**

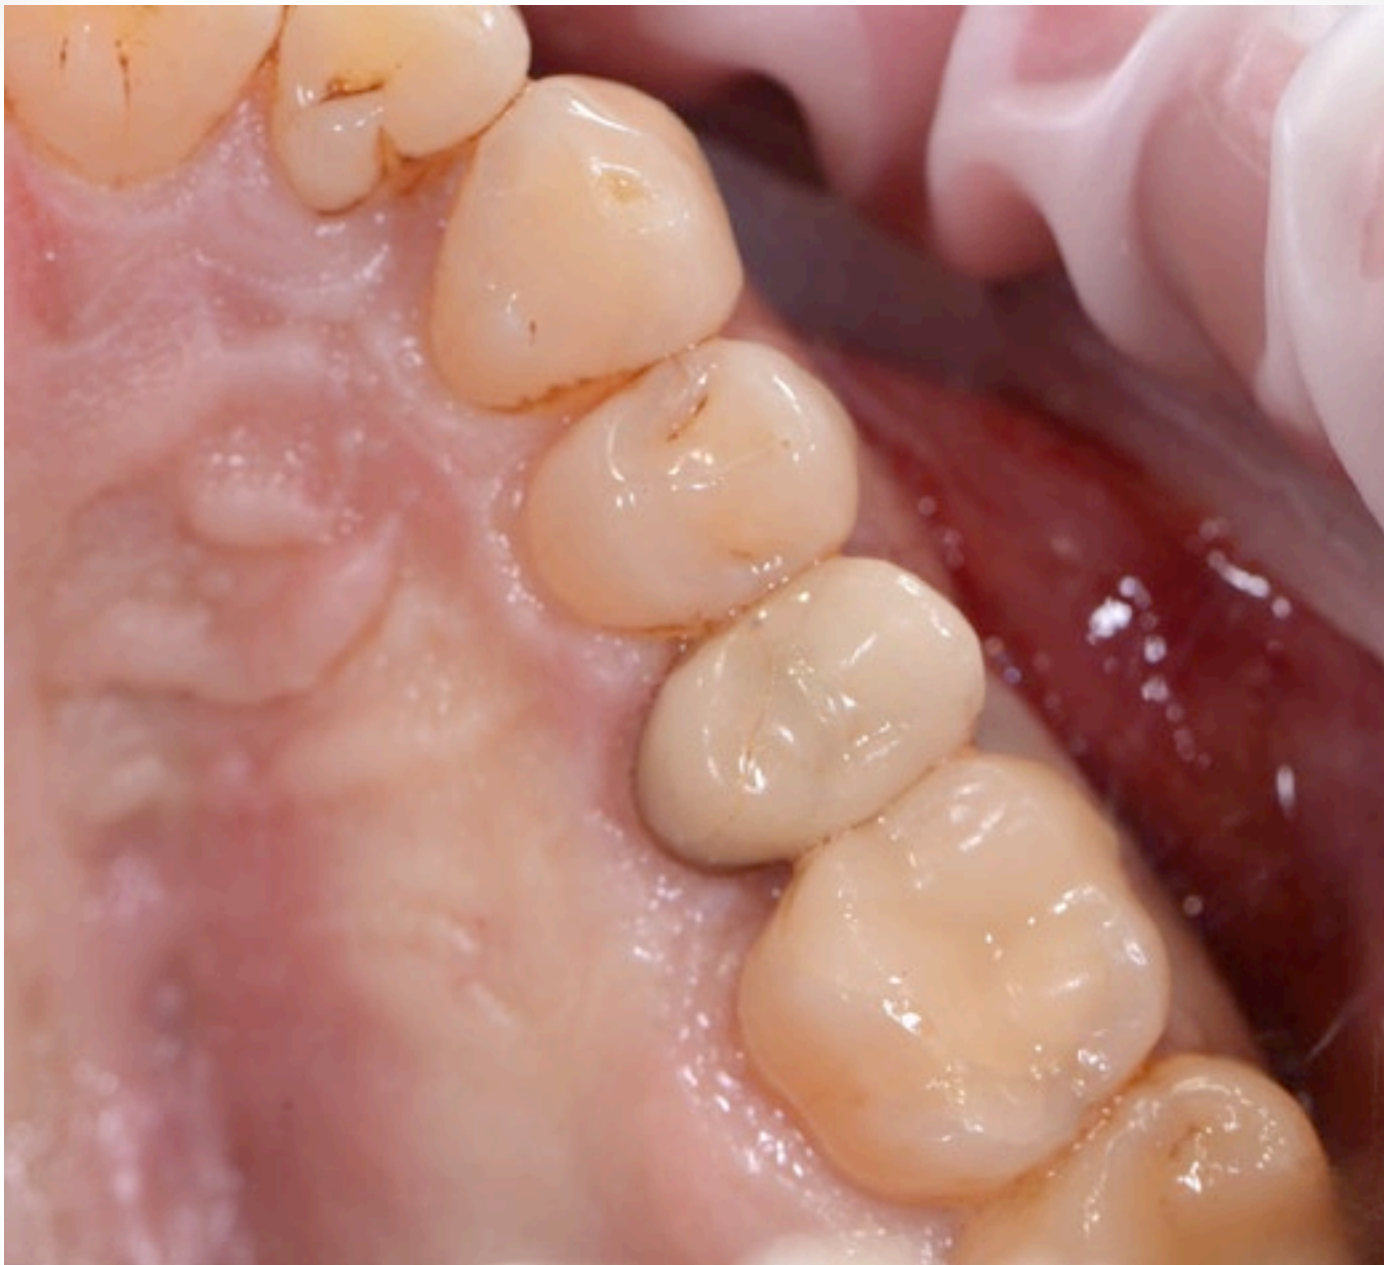
**Occlusal Pre-Op**

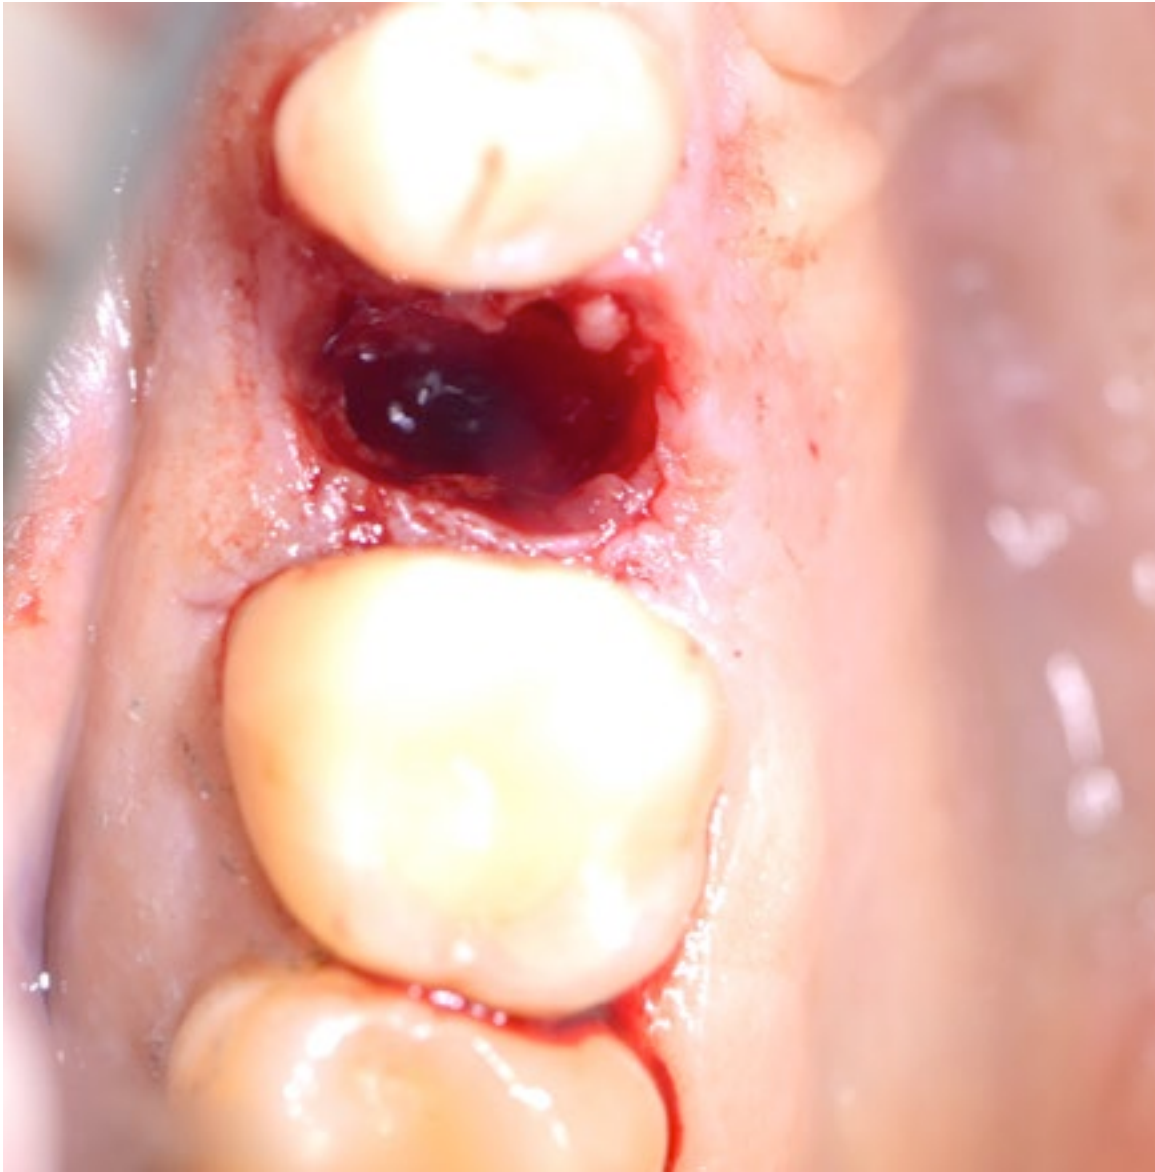
**Perfectly preserved socket architecture with minimal to no Bone damage or Soft Tissue mutilation**

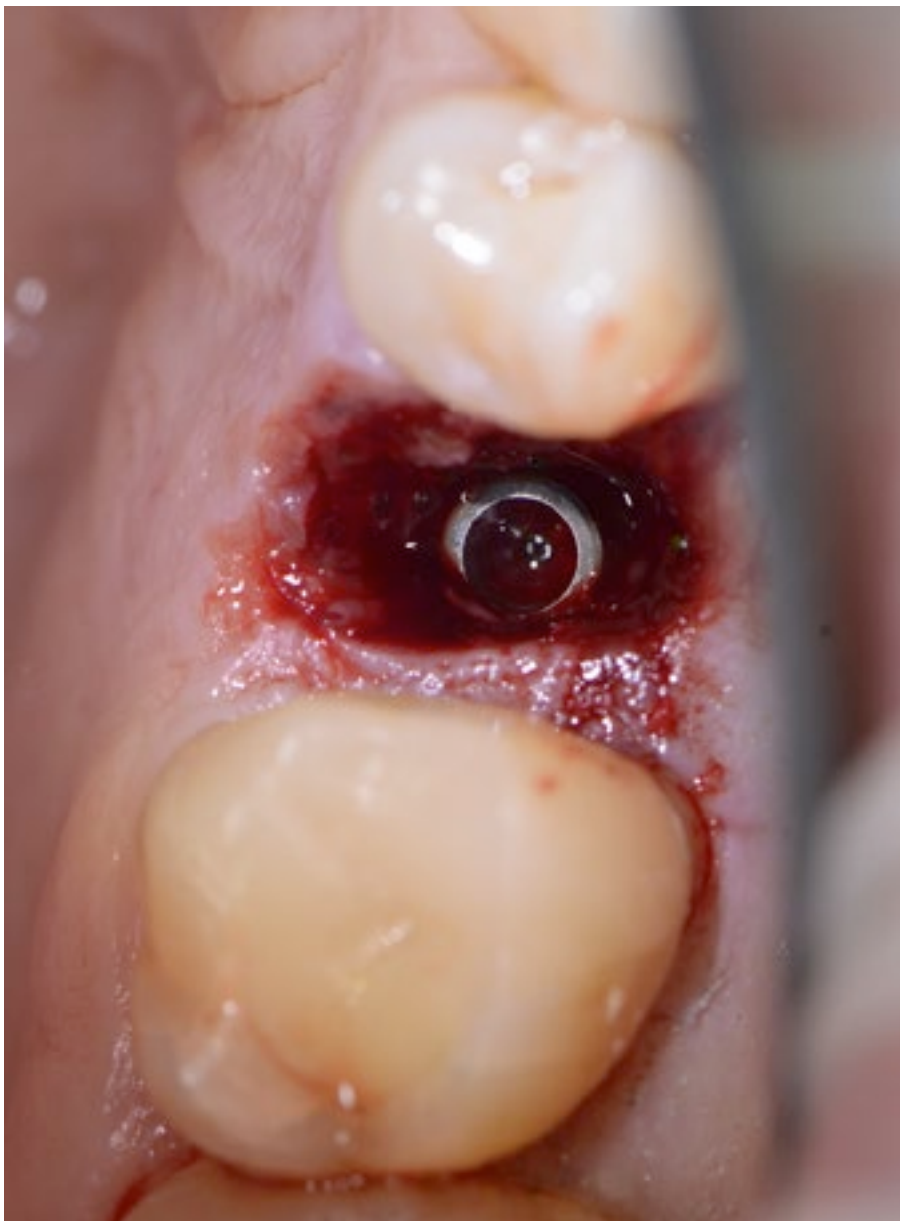
**Implant Placed – No Buccal bone lost during extraction so no need for full flap & GBR greater predictability for success**

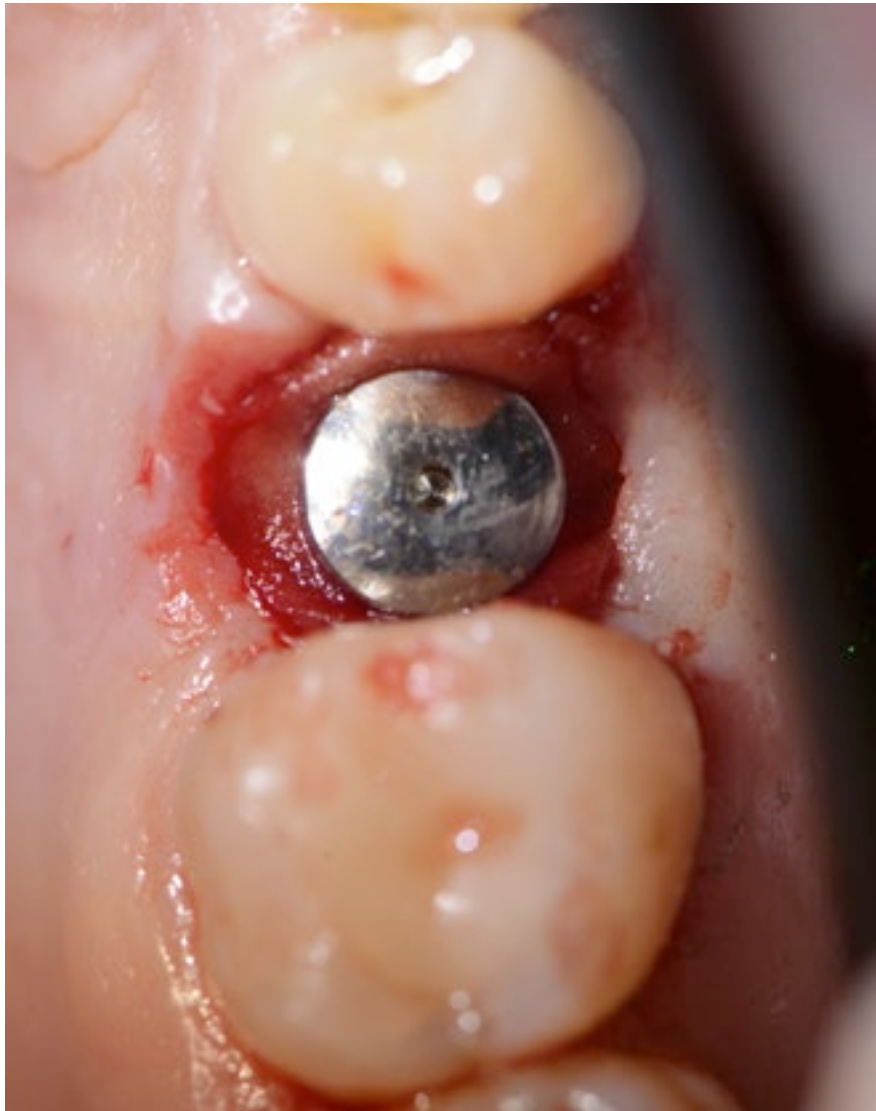
**Case Complete – Everything as predicted as Benex allowed preservation of site.**
